# **HYDRAULIC AND GEOMORPHOLOGIC EVALUATION**

## **Analysis of Wood Loading in the Ozette River and Its Effect on Water Levels in Lake Ozette, Clallam County, Washington**

Prepared for

Makah Indian Tribe  
Makah Fisheries Management

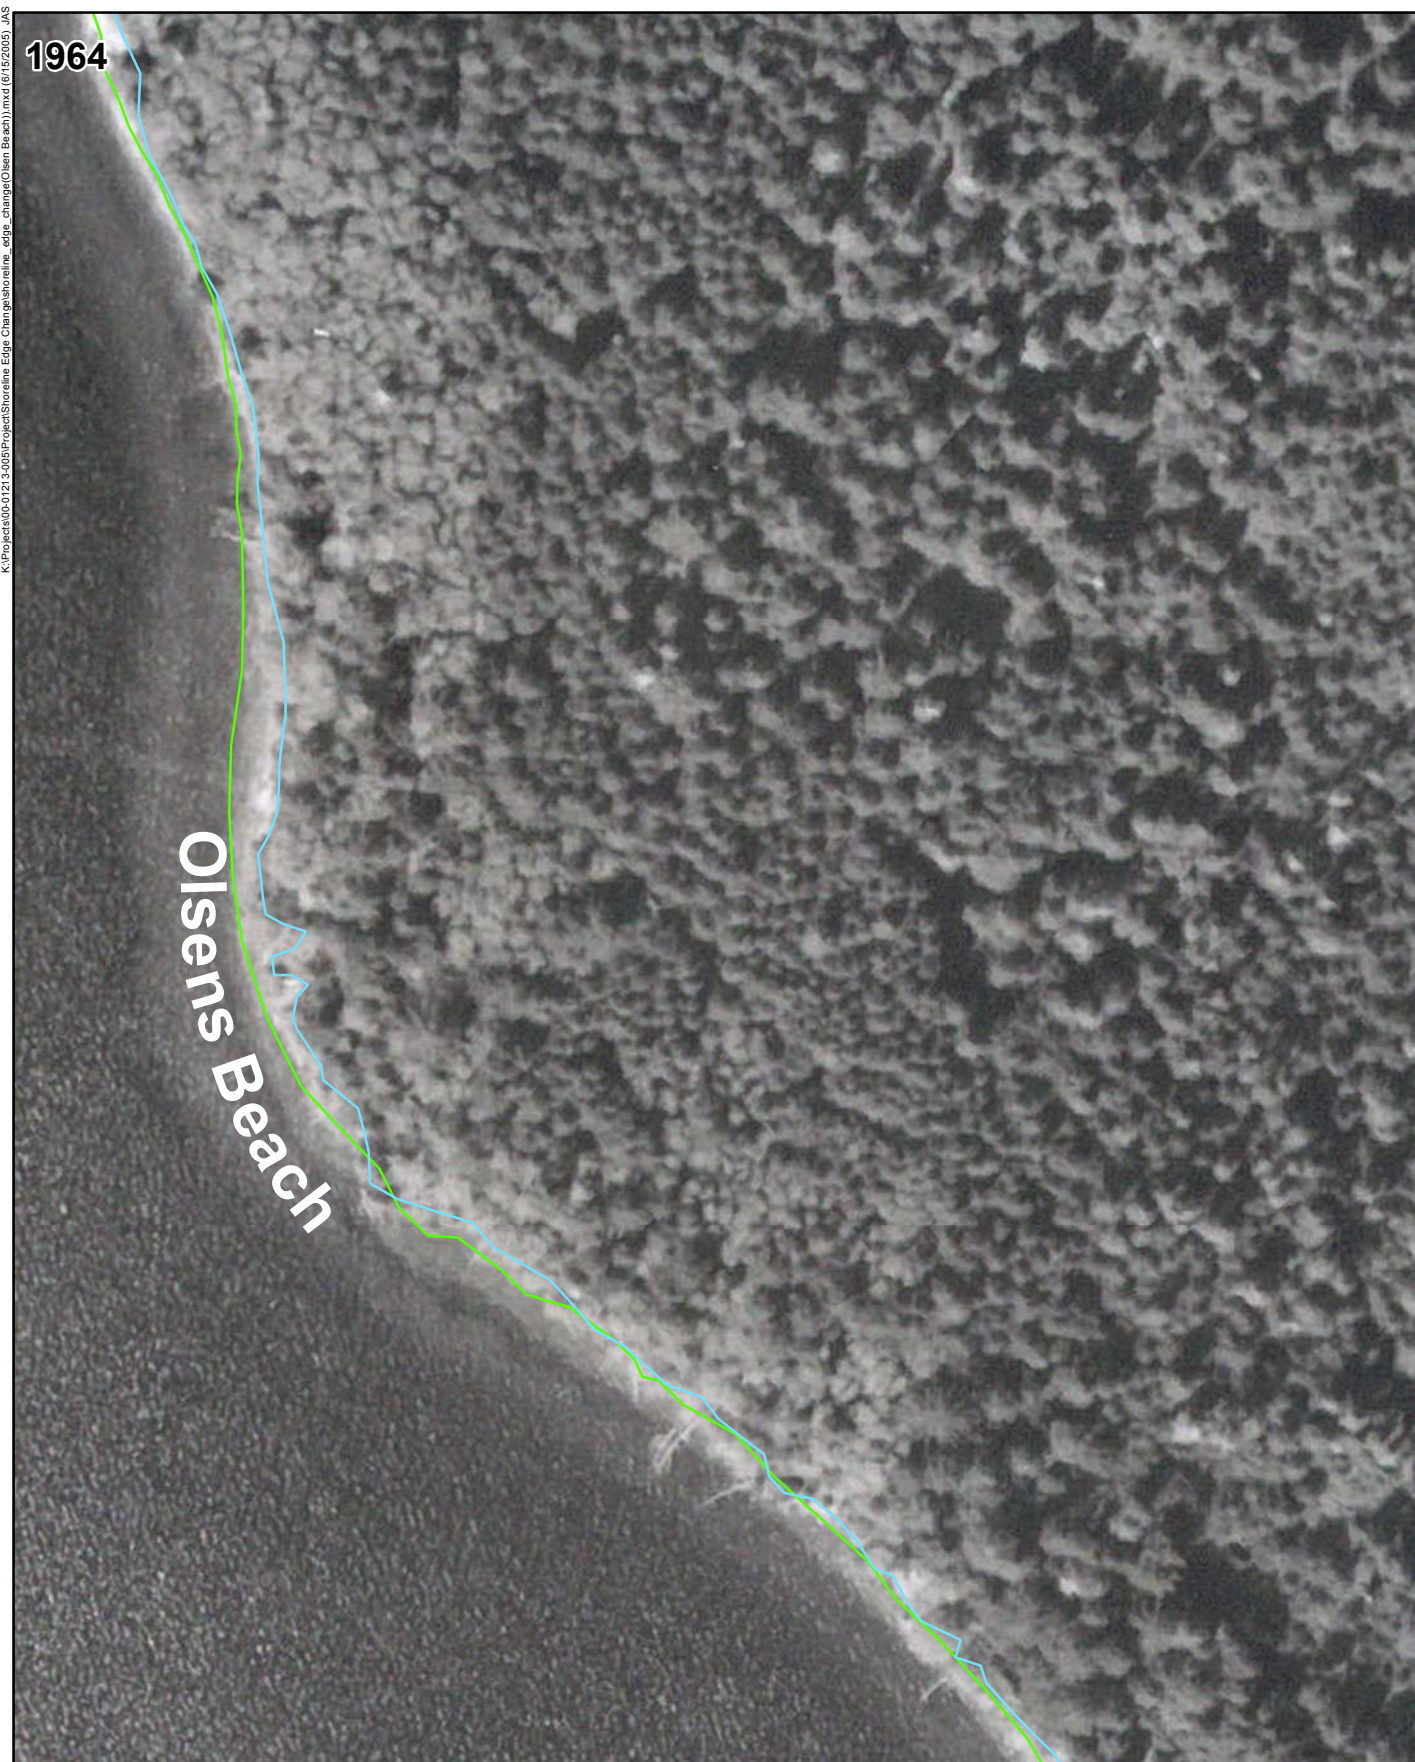
Figure 12. Shoreline changes at Olsens Beach between 1964 and 2003, Lake Ozette, Washington .

Olsens Beach has shown evidence of vegetative encroachment between 1964 and 2003 (Figure 12). The areas of non-vegetated beach in the 1964 photos are difficult to distinguish, but referring to the unrectified 1953 photos (Appendix A) reveal areas of exposed beach to the north of the point. These areas of beach had been completely vegetated by 2003. The average slope of Olsens Beach is approximately 9 percent; therefore, a 3.3-foot (1-meter) drop in WSE would result in an approximate 33-foot (10-meter) decrease in beach inundation.
